# UNDERSTANDING MATERIALS

University of York  
MA in Conservation Studies  
Assessed Essay no.2  
Candidate PGST009102842  
Exam number 41083

Question: ‘*What is your understanding of the relationship between the practical issues of using appropriate materials - e.g. lime, stone, timber, metals, brick, earth, concrete, - in the repair of historic or landmark buildings and the philosophical issues of authenticity?*

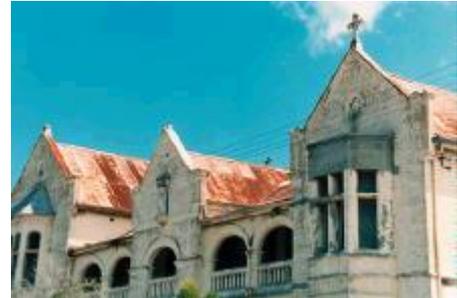
**St Brigid's Convent (1898), Northbridge, Perth, Western Australia, in 1997.**  
Gable crucifix details destroyed by corroding metal fixing rods, gutter and rain goods not maintained - allowing water ingress, roof sheeting corroded - requiring reconstruction, and inappropriate cement rendered repair work.

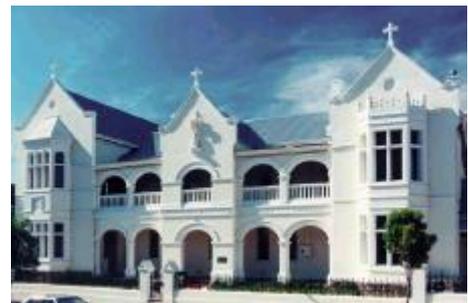
**St Brigid's Convent (1898), Northbridge, Perth, Western Australia, in 2000.**  
After *repair* (by *restoration* and *reconstruction*) based on documentary evidence and using *appropriate* materials to retain *authenticity*.

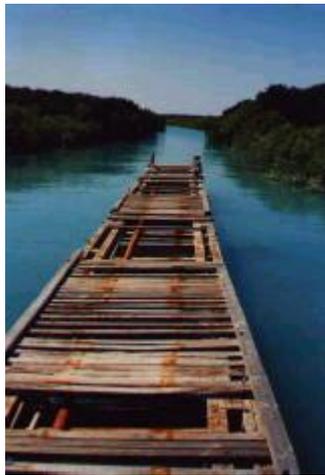
**Figure 1: Streeter’s Jetty (c.1897) at Broome, Western Australia, in 1998.**

A structure that periodically requires complete reconstruction.

The characteristic appearance and the longevity of the jetty is resultant from use of authentic, traditional materials.

Some timber structures of cultural significance have been designed that require regular replacement of materials. This type of design is shown in two examples of jetties in Western Australia (WA), different in scale, but both subject to constant weathering in a ‘hostile’ marine environment, to attack from marine borers, and to cyclonic loading from storms in the Indian Ocean. The humble Streeter’s Jetty at Broome, WA, is a comparatively short (~70 metres long) timber structure built in the 1890s to facilitate the loading and unloading of pearling luggers. The Jetty is built amongst mangroves, is subject to 10 metre tidal movements, and is located in a monsoon climatic area. The Jetty thus has extremely wide variations of moisture content in the timber. The local eucalypt Cadjebut timber (an extremely durable hardwood) has been found over perhaps four separate reconstructions to have the maximum resistance to the decay resultant from the wide thermal and moisture movements in the area. The ‘paperbark’ type covering of the timber is left on the timber piles driven into the seabed, and gradually ‘flakes’ as a sacrificial covering. A special stand of trees has been set aside for the ongoing renewal of the ‘bush-cut’ piles, a process that is necessary perhaps every thirty to forty years.

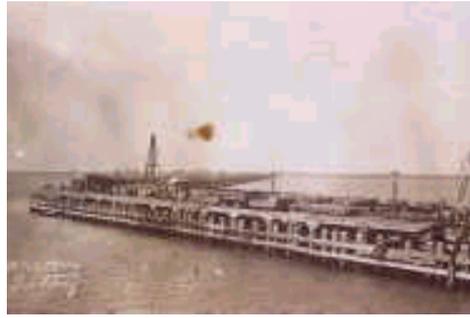
**Figure 2: ‘One Mile Jetty’ (1896) at Carnarvon, Western Australia, c.1922.**

A structure with a continuous program of restoration and reconstruction. The ongoing use of traditional materials and skills is maintaining authenticity.

The West Australian hardwood Jarrah (*eucalyptus marginata*) has long been known for its durability and hardness. The ‘One-Mile Jetty’ at Carnarvon, WA, has Jarrah piles, stringers, bearers, and decking; and has had a continuous program of replacement of this material since 1896. At times as many as 16 men have been involved in full-time repair work. The structure has withstood Category 5 cyclones with success due to the flexibility embodied in the timber structure. Engineers and architects alike have come to recognise that if the galvanised metal fixings are maintained and replaced as required, and the marine borers are discouraged from activity in the pile footings by ‘wrapping’, then the materials replacement program is sustainable. Weathered timber is cut back to the useful cores when structural section is lost, and the material then reused elsewhere. The workmen employed to do this replacement work in the past have passed on traditional skills to new generations, and this allows the timber to continue to be used in an authentic manner.

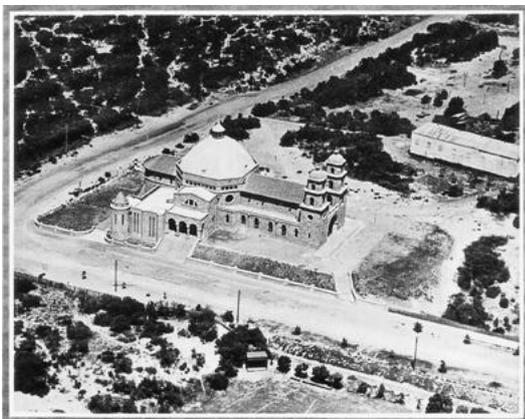
**Figure 3: St Francis Xavier Cathedral at Geraldton, Western Australia (1918-38):** Corrugated asbestos fibre cement roof sheeting to the dome in 1938. Timber shingles to the nave and sanctuary roofs from 1918, soon to be replaced with asbestos sheeting. Can the cathedral now be roofed in accord with the architect's original design intent? Would a green copper dome to the cathedral, as originally envisaged by the architect, similar to the George Street, Edinburgh bank example shown below, meet with approval? Is this authenticity?

The roof sheeting has now decayed in the very abrasive semi-marine environment, and poses health and safety issues. Research has revealed that the architect's original design preferred the use of clay tiles for nave and sanctuary roofs, and of copper for the dome to the crossing. For financial reasons these materials were not originally placed, and may be the correct material to place now. However many other factors need to be taken into account. Is the existing structure capable of taking the new loadings without significant modification, and are social factors (local people have come to admire the old roof appearance) of cultural importance?

Also of consideration is the fact that encapsulation of the asbestos fibres in the sheeting by a coating may be possible, and the issue of appropriate materials and authenticity in this case is not clearly resolved. The St Francis Xavier Cathedral at Geraldton is from a relatively recent period, and some would ascribe a lesser value to this structure, than say a medieval Gothic cathedral. However, the principles of materials usage and authenticity remain the same. **A conservator must determine and document work with the aid of clear conservation policy, policy that ensures the retention of cultural significance.**

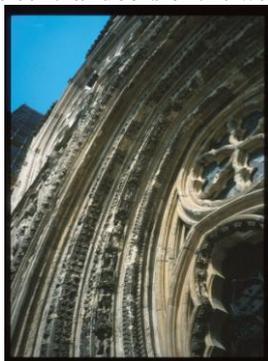
**Figure 4: Detail around the arch over the central doors of the west front of York Minster, England c.1998.**

Illustrates loss of detail with weathering. As a philosophical question in relation to authenticity in conservation:  
‘Should the stone work be replaced with new work, if the old cannot be accurately reconstructed?’
